PROJECT LARKSPUR

AMCHITKA ISLAND, ALASKA

INVESTIGATIONS OF
AREAS 1, 2, 3 AND 4

US ARMY ENGINEER DISTRICT, ALASKA

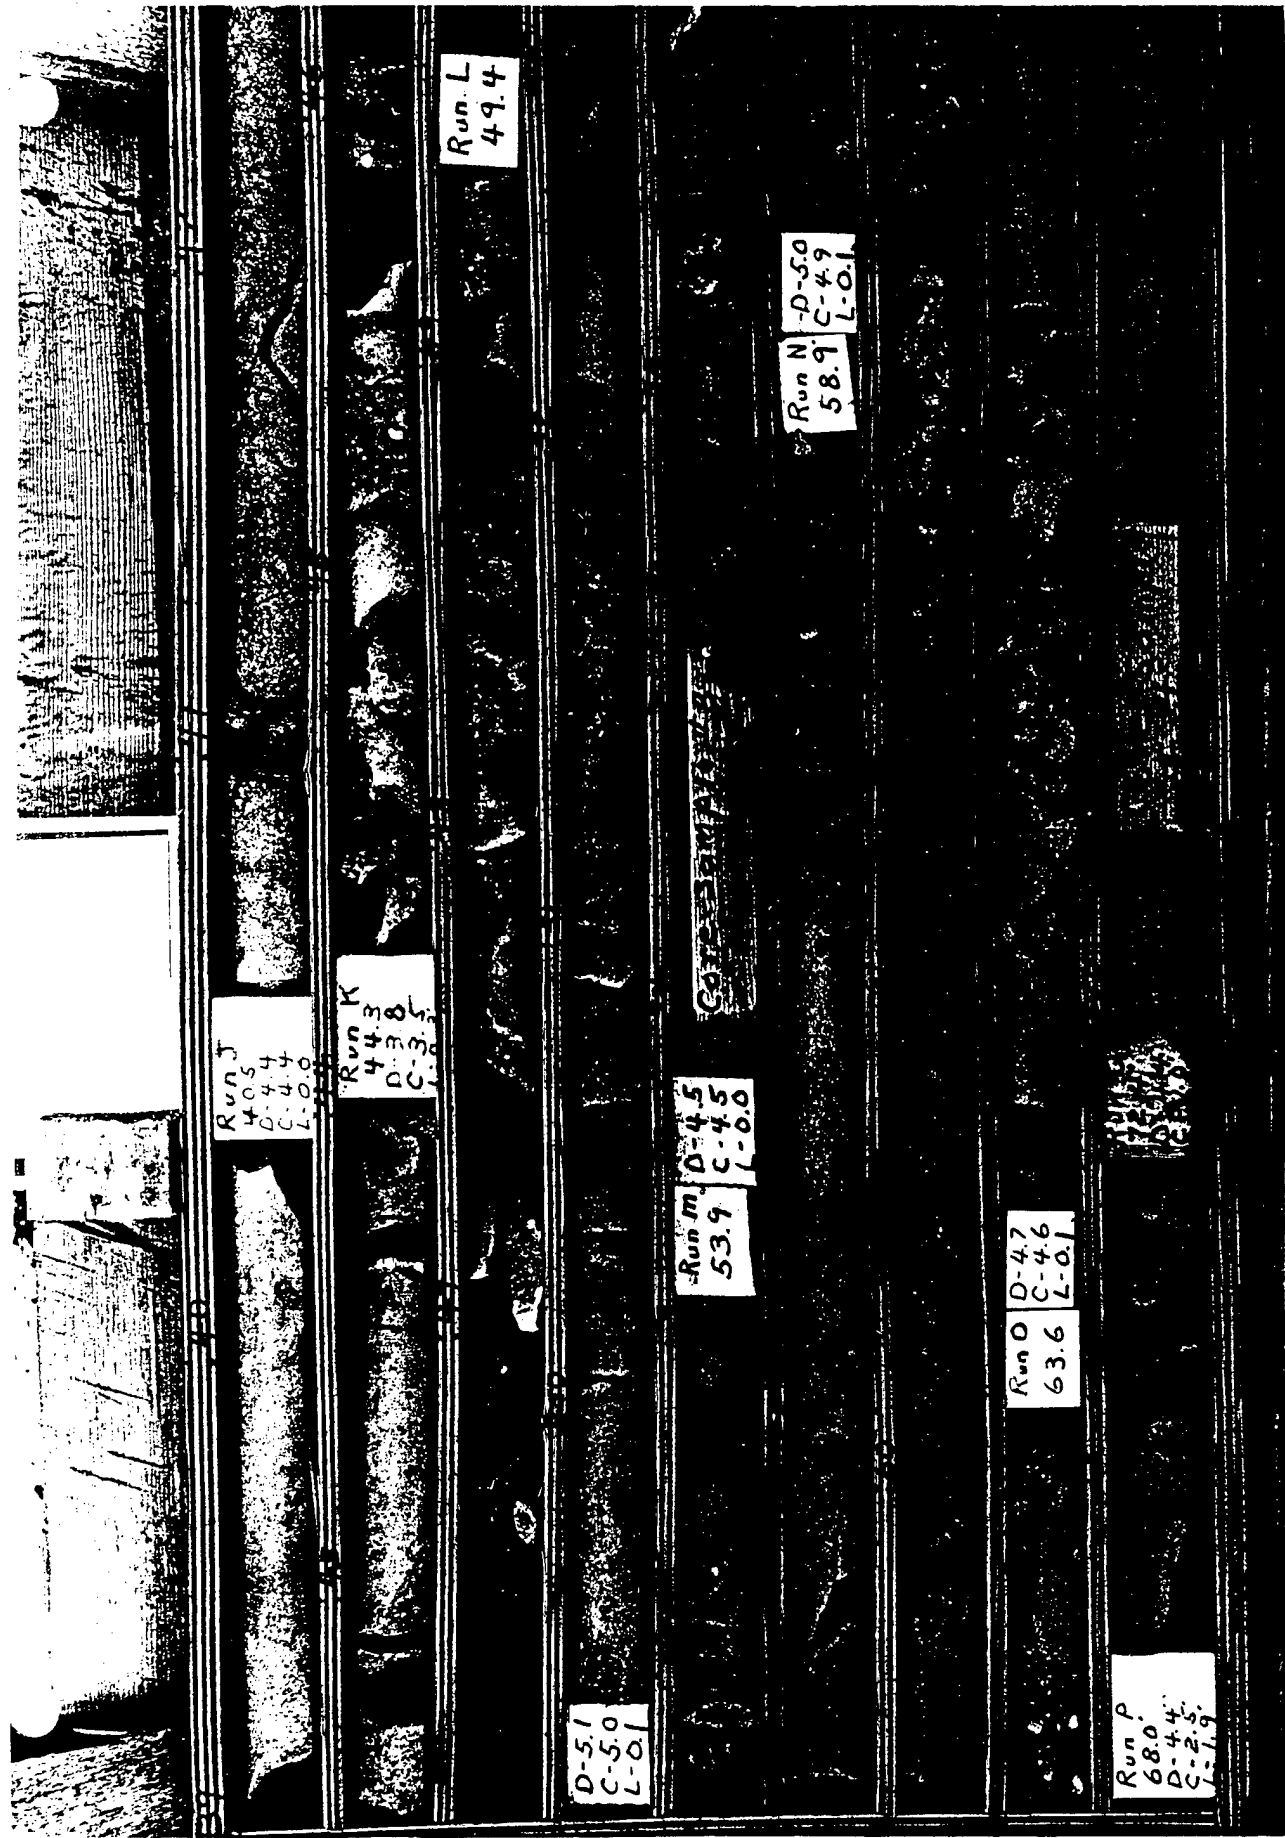
CORE SAMPLES, CORE HOLE 64-D-4, (AREA 1).

- PHOTO 28 - Area 1; cores from core hole 64-D-4
- PHOTO 29 - Area 3; cores from core hole 64-D-2
- PHOTO 30 - Area 3; cores from core hole 64-D-2
- PHOTO 31 - Area 3; cores from core hole 64-D-2

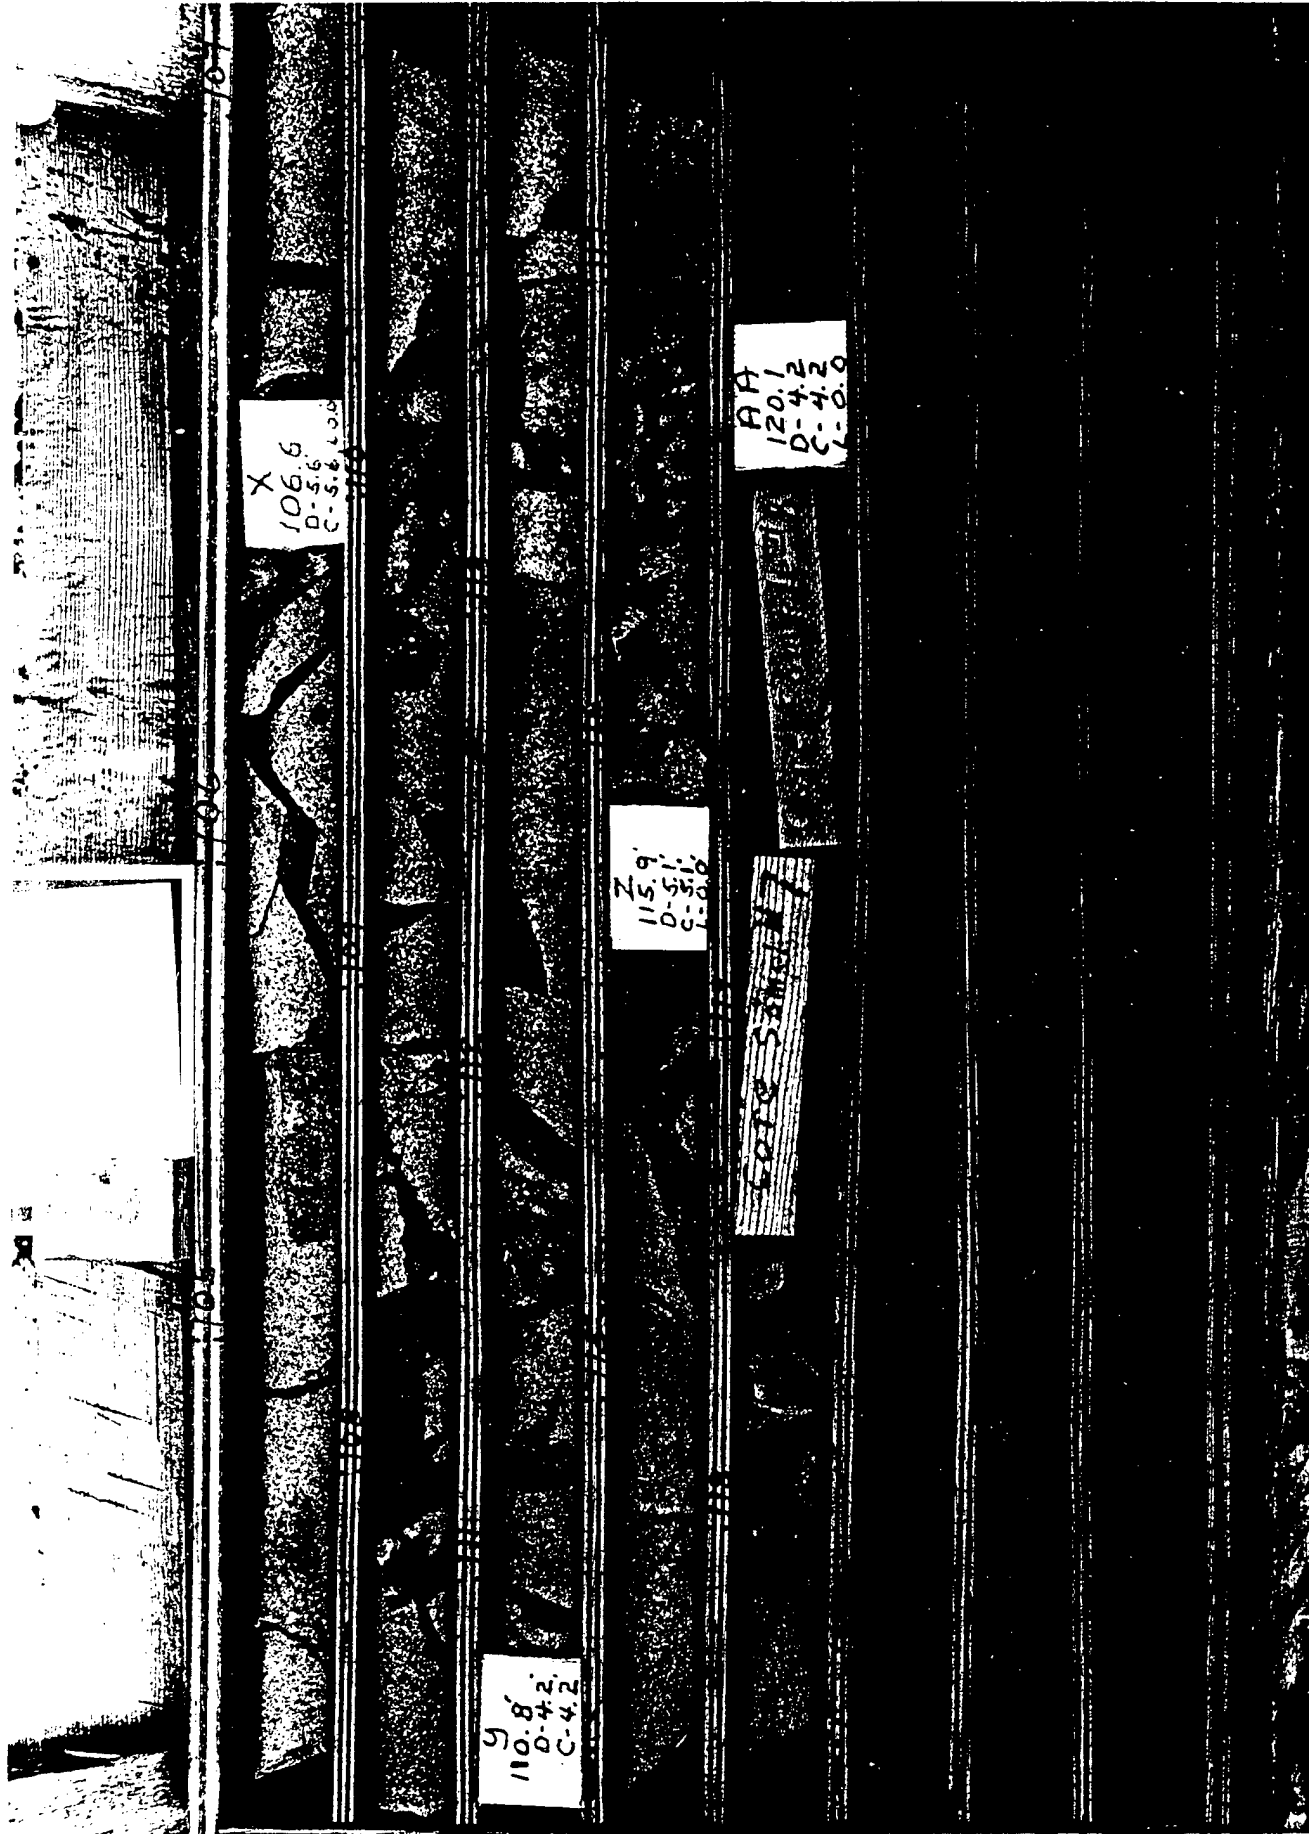
PHOTO 28

CORE SAMPLES, CORE HOLE 64-D-4, (AREA 1).

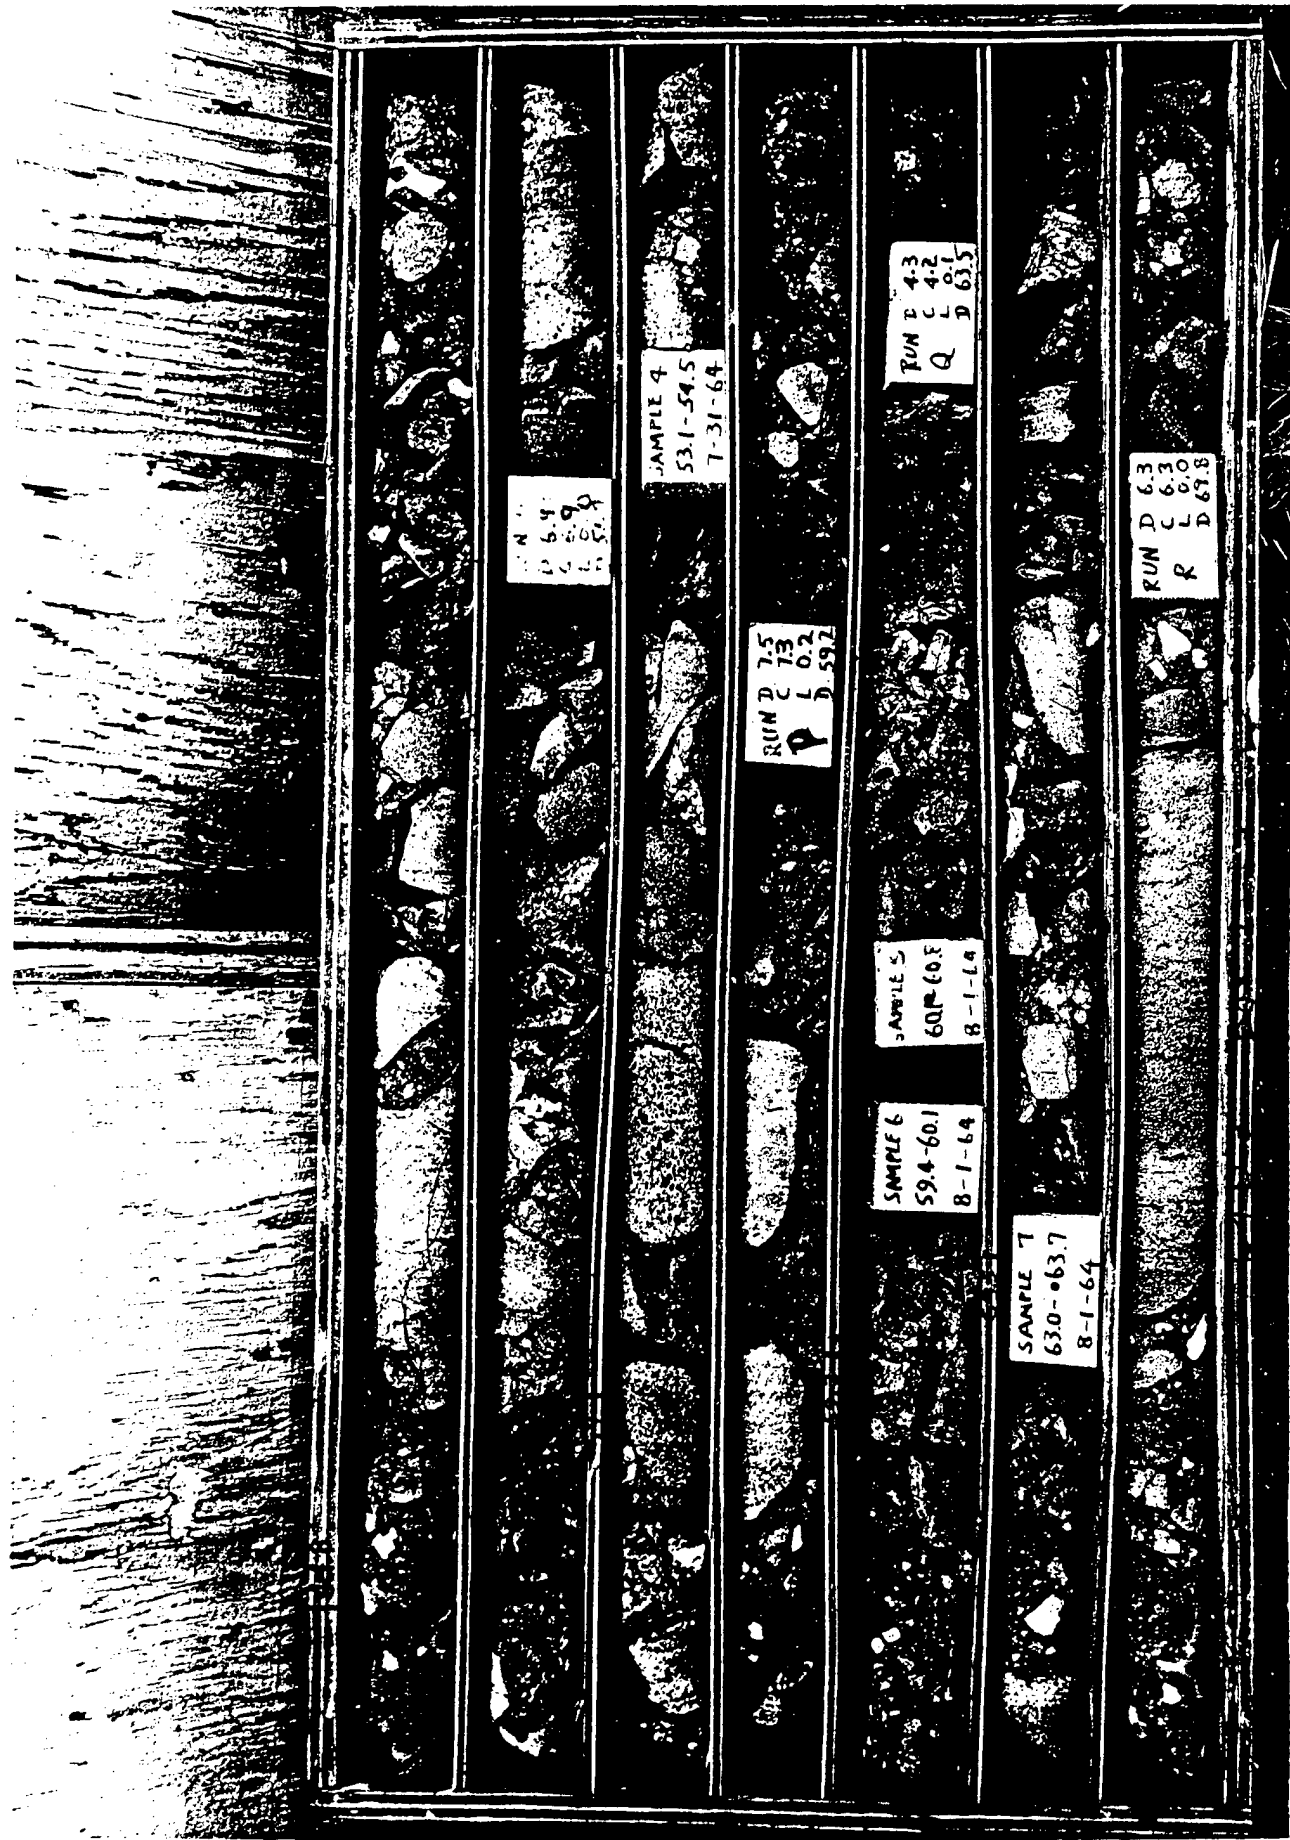
CORE SAMPLES, CORE HOLE 64-D-3, (AREA 4).
